**[Docket No. 2000-SW-15-AD; Amendment 39-12175; AD 2001-07-09]**

**Airworthiness Directives; MD Helicopters Inc. Model MD-900 Helicopters**

**2001-07-09 MD HELICOPTERS INC:** Amendment 39-12175. Docket No. 2000-SW-15-AD.  
Supersedes Emergency AD 99-26-20, Docket No. 99-SW-89-AD.

**Applicability:** Model MD-900 helicopters, with main rotor upper hub (hub) assembly, part number (P/N) 900R2101006-105 or 900R2101006-107, installed, certificated in any category.

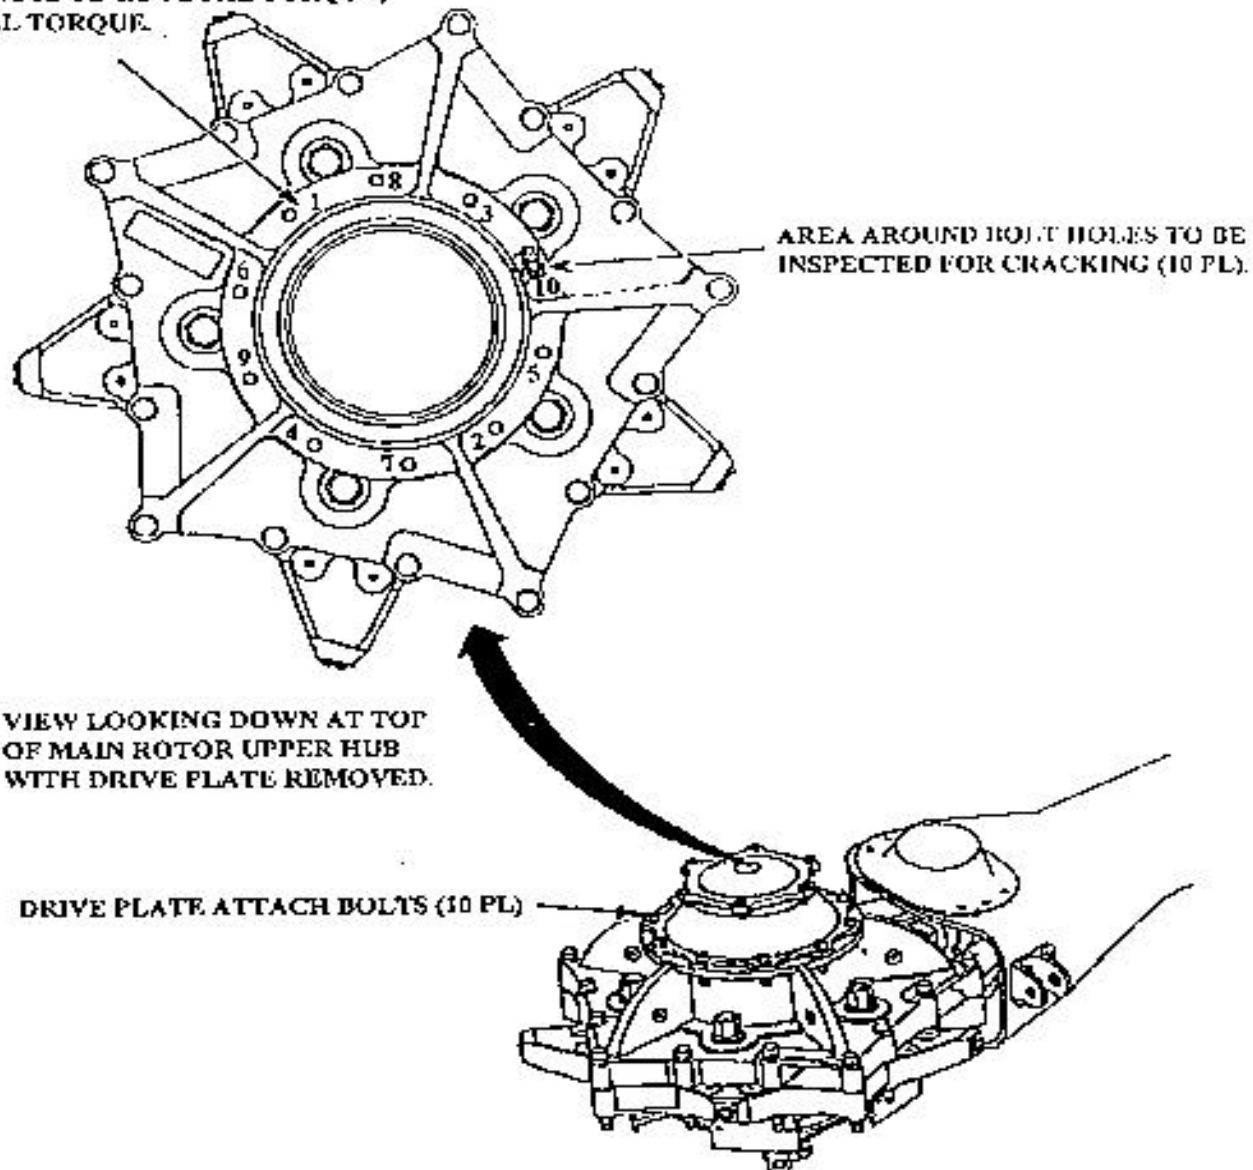
**Figure 1. Main Rotor Upper Hub Assembly Inspection.**

- (v) Using paint stripper (Consumable Item List C313 or equivalent) and cleaning solvent (C420 or equivalent), remove the paint from the upper mating surface of the hub assembly to enable an accurate visual inspection of the drive plate attachment bolt hole (bolt hole) area for cracking (Figure 1). Ensure the paint stripper and solvent DO NOT contaminate the upper bearing and upper grease seal areas.

- (vi) Using a 10-power or higher magnifying glass and bright light, inspect the mating surface area and the area around and inside the 10 bolt holes of the hub assembly for a crack. If a crack is found, prior to further flight, replace the hub assembly with an airworthy hub assembly.

- (i) If present, remove sealant from the drive plate attachment to the hub assembly.
- (ii) Mark the main rotor hub holes, bolts, and nuts to correspond with the drive plate hole numbers (see Figure 1).

- (viii) Reinstall the main rotor drive plate using 10 new sets of replacement attachment hardware. Torque the nuts to 160 inch pounds above locknut locking/run-on torque in the sequence shown (Figure 1). Record in the rotorcraft logbook, or equivalent record, the locknut locking/run-on torque for each nut.

1. MAIN ROTOR DRIVE PLATE ATTACHMENT  
HARDWARE TORQUE SEQUENCE.
2. NUMBERING MAY START AT ANY HOLE.
3. TORQUE NUTS TO 1/2 TOTAL TORQUE,  
THEN FULL TORQUE.
